Technical Note N-1170

HIGH EXPLOSIVE FIELD TEST OF HARDENED ELECTRICAL GENERATORS

May 1971

NAVAL CIVIL ENGINEERING LABORATORY
Port Hueneme, California 93043

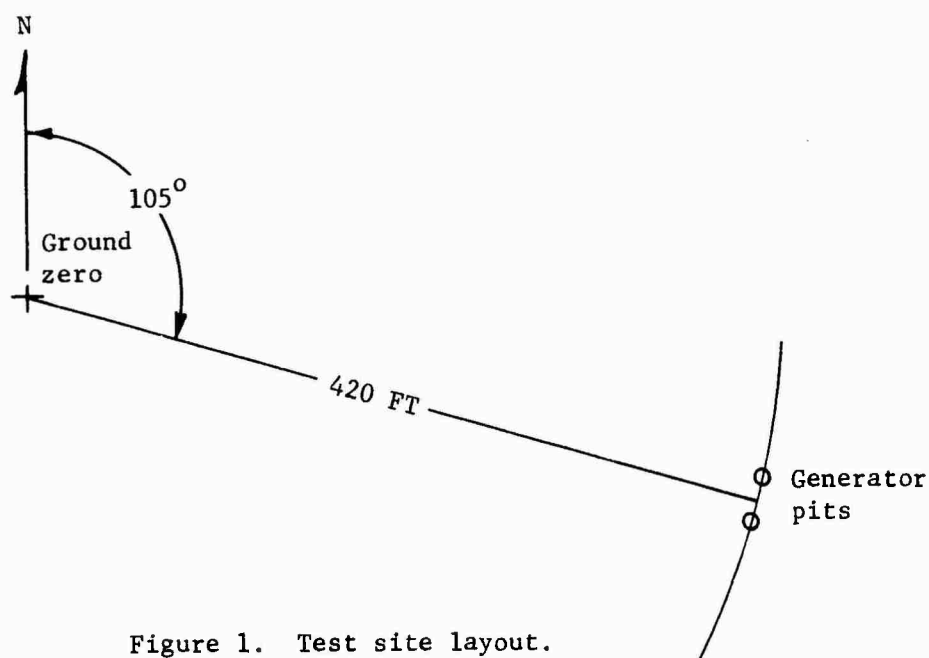
Figure 1. Test site layout.

Two 10 kilowatt diesel engine driven generator sets in grate-covered pits would be subjected to simultaneous air blast and ground shock at a 100 psi overpressure level 420 feet from ground zero, as shown in Figure 1. The blast would result from detonation of a surface-tangent, spherical charge of 500 tons of TNT. The generator sets were to have their longitudinal centerlines oriented such that the first would be parallel to the blast wave front and the second would be perpendicular to the blast wave front. Both generators were to be operating under load during the test. Instrumentation to provide data on the air blast and ground motion environment and on the response of both the engine and the generator output to the environment were to be installed. Hardening of the generator sets was to be restricted to those components damaged in the previous

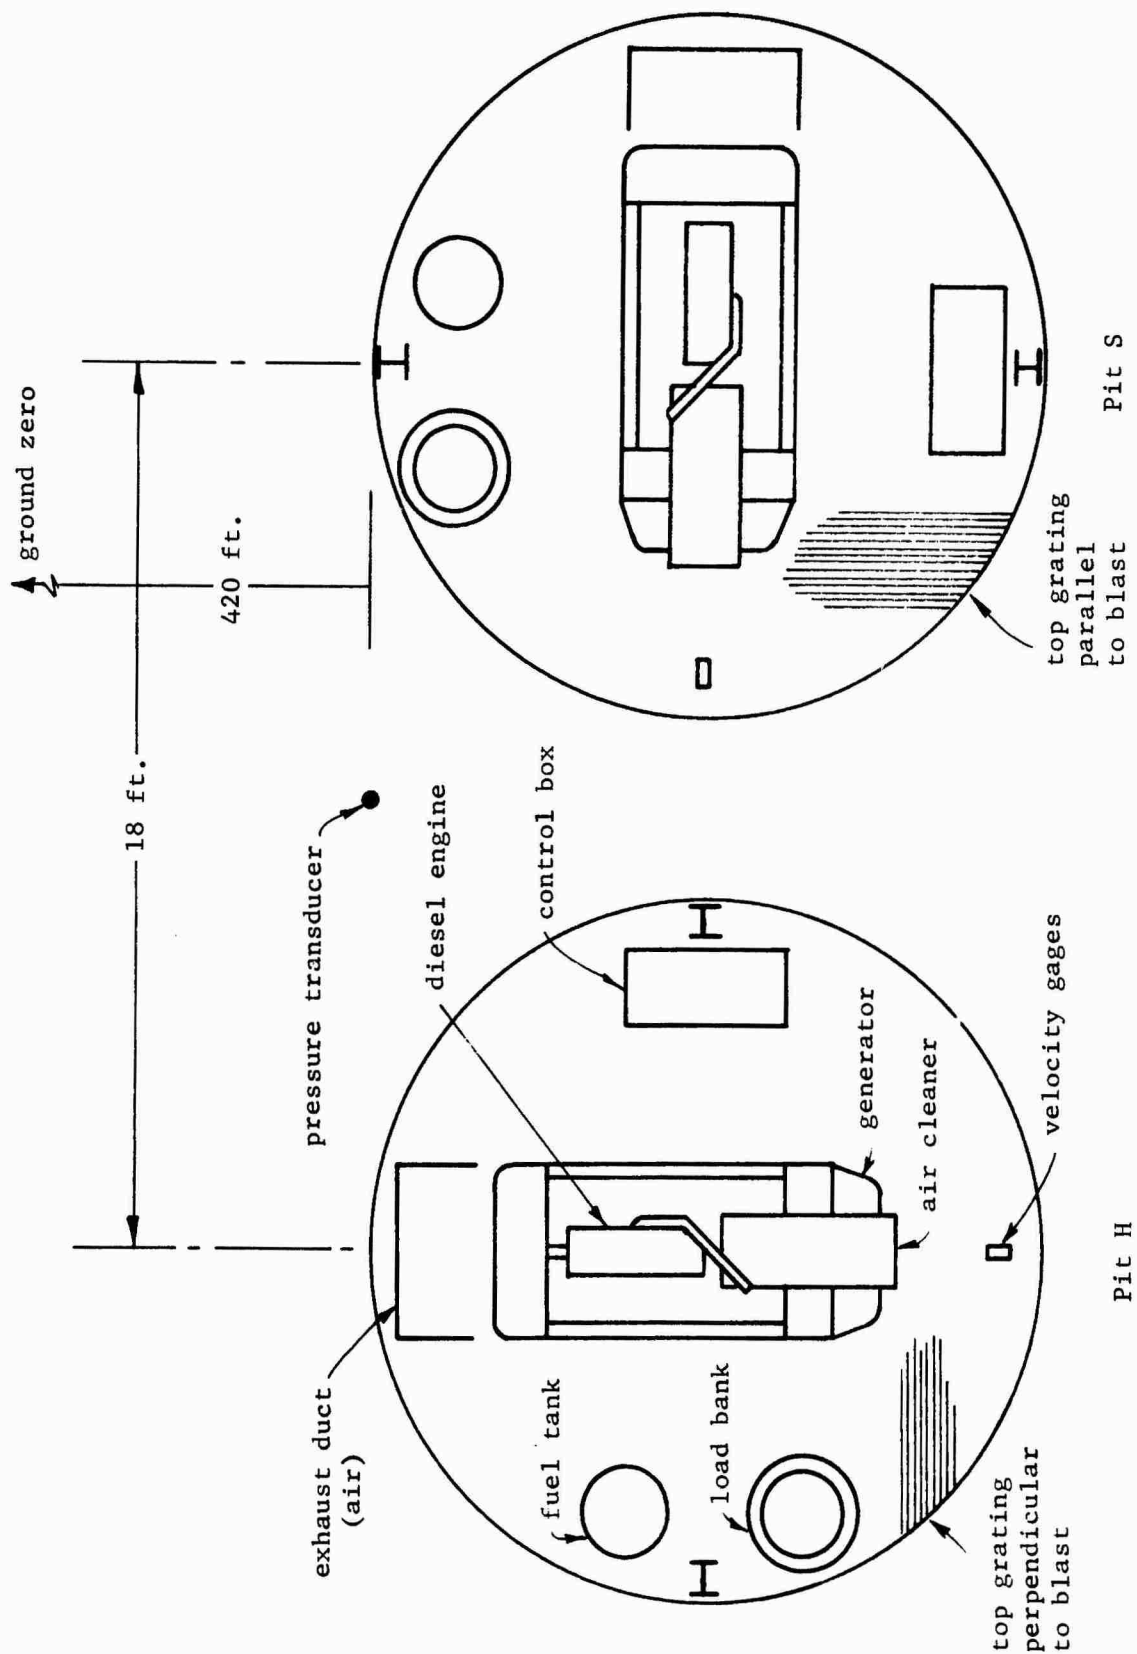
Figure 3. Equipment layout in pits.

Two identical grate-covered pits fabricated of corrugated steel and having two-layer grate covers anchored to a circular reinforced concrete girdle were located 420 feet from ground zero where the predicted overpressure would be about 100 psi. The pits were provided with 8-inch-thick, reinforced concrete floors in which I-beams were embedded to provide anchors for the generator mounting skid as shown in Figure 2. The tops of the pits were located 2 inches above the existing grade and the pits were located 18 feet from center to center. The completed pit installation is shown in Figure 3.

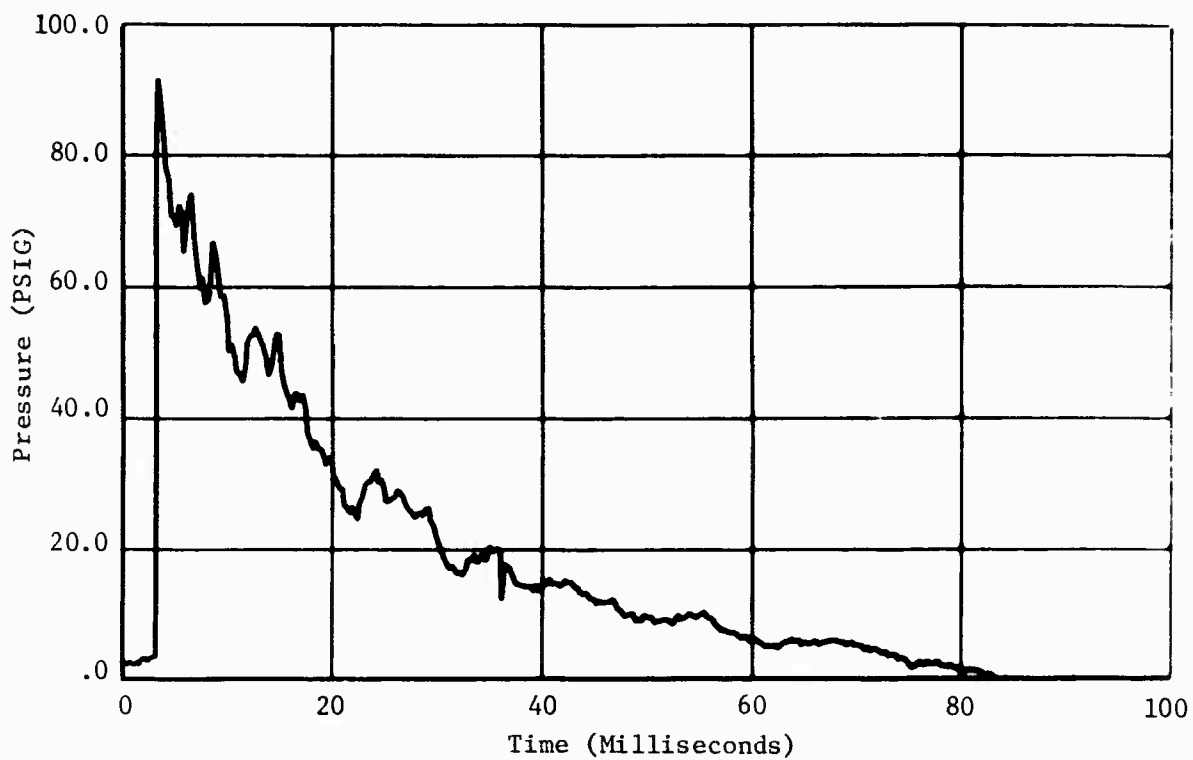
Figure 8. Free field overpressure time history.

The recorded free field overpressure time history, Figure 8, shows that the peak overpressure was 94 psi. The blast wave arrival time of 69.5 milliseconds and the overpressure positive phase duration of 80.5 milliseconds agreed with predictions by the U. S. Technical Director.

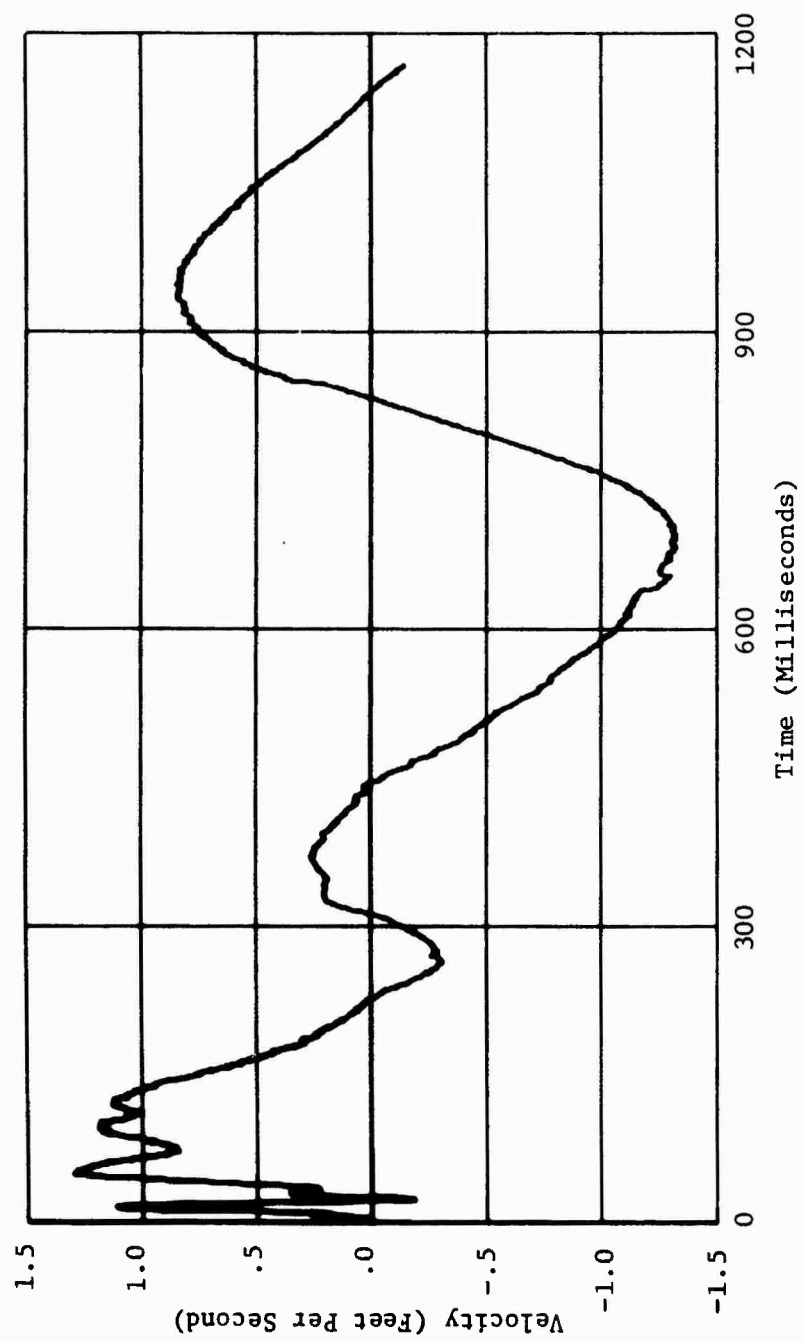
Figure A-10. Horizontal velocity of floor in Pit S.

Figure A-10 presents the horizontal velocity history of the Pit "S" floor while Figures A-11 and A-12 are the horizontal displacement and acceleration histories calculated from the velocity data plotted in Figure A-10.
